Contract #: 04-0120F4Cty: SF/ALA Rte: 80 PM: 13.2/13.9File #: 69.28**WELDING INSPECTION REPORT****Resident Engineer:**Pursell, Gary**Address:** 333 Burma Road**City:** Oakland, CA 94607**Report No:** WIR-008637**Date Inspected:** 15-Aug-2009**Project Name:** SAS Superstructure**OSM Arrival Time:** 700**Prime Contractor:** American Bridge/Fluor Enterprises, a JV**OSM Departure Time:** 1900**Contractor:** Zhenhua Port Machinery Company, Ltd (ZPMC), Changxing Island **Location:** Shanghai,China**CWI Name:** Lv Li Qing / Shen Fu You**CWI Present:** Yes No**Inspected CWI report:** Yes No N/A**Rod Oven in Use:** Yes No N/A**Electrode to specification:** Yes No N/A**Weld Procedures Followed:** Yes No N/A**Qualified Welders:** Yes No N/A**Verified Joint Fit-up:** Yes No N/A**Approved Drawings:** Yes No N/A**Approved WPS:** Yes No N/A**Delayed / Cancelled:** Yes No N/A**Bridge No:** 34-0006**Component:** OBG Assembly**Summary of Items Observed:**

OBG Bay No. 14

WELDING INSPECTION REPORT

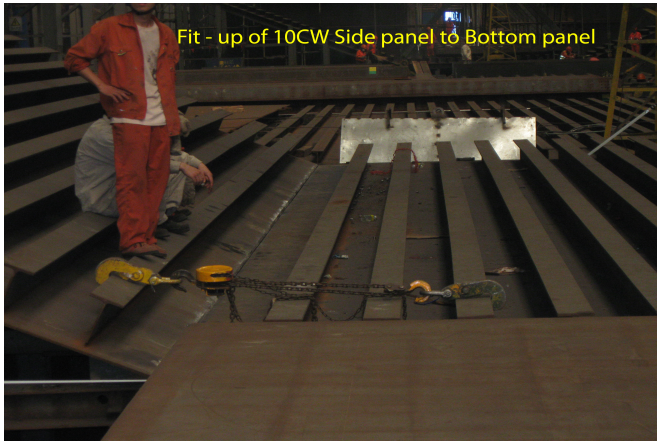
On this date the Quality Assurance Inspector (QA) observed ZPMC Fitting - up Side panel to Bottom panel on assembly 10CW using a mechanical pulling device attached to a T-Stiffener on the side panel and a T-stiffener on the bottom panel. It appears to the QA inspector some distortion is being created in the T-stiffeners. See photograph for additional information.
